SITE SUMMARY FOR POLYCHLORINATED BIPHENYL DISPOSAL DRY DOCK AREA
ROOSEVELT ROADS SITE 9 NAVAL ACTIVITY PUERTO RICO
7/25/1993
VERSAR, INC.

**SITE SUMMARY FOR PCB DISPOSAL-DRY DOCK AREA,
ROOSEVELT ROADS
(SITE NO. 9)**

Versar Job No. 5295.3

July 25, 1991

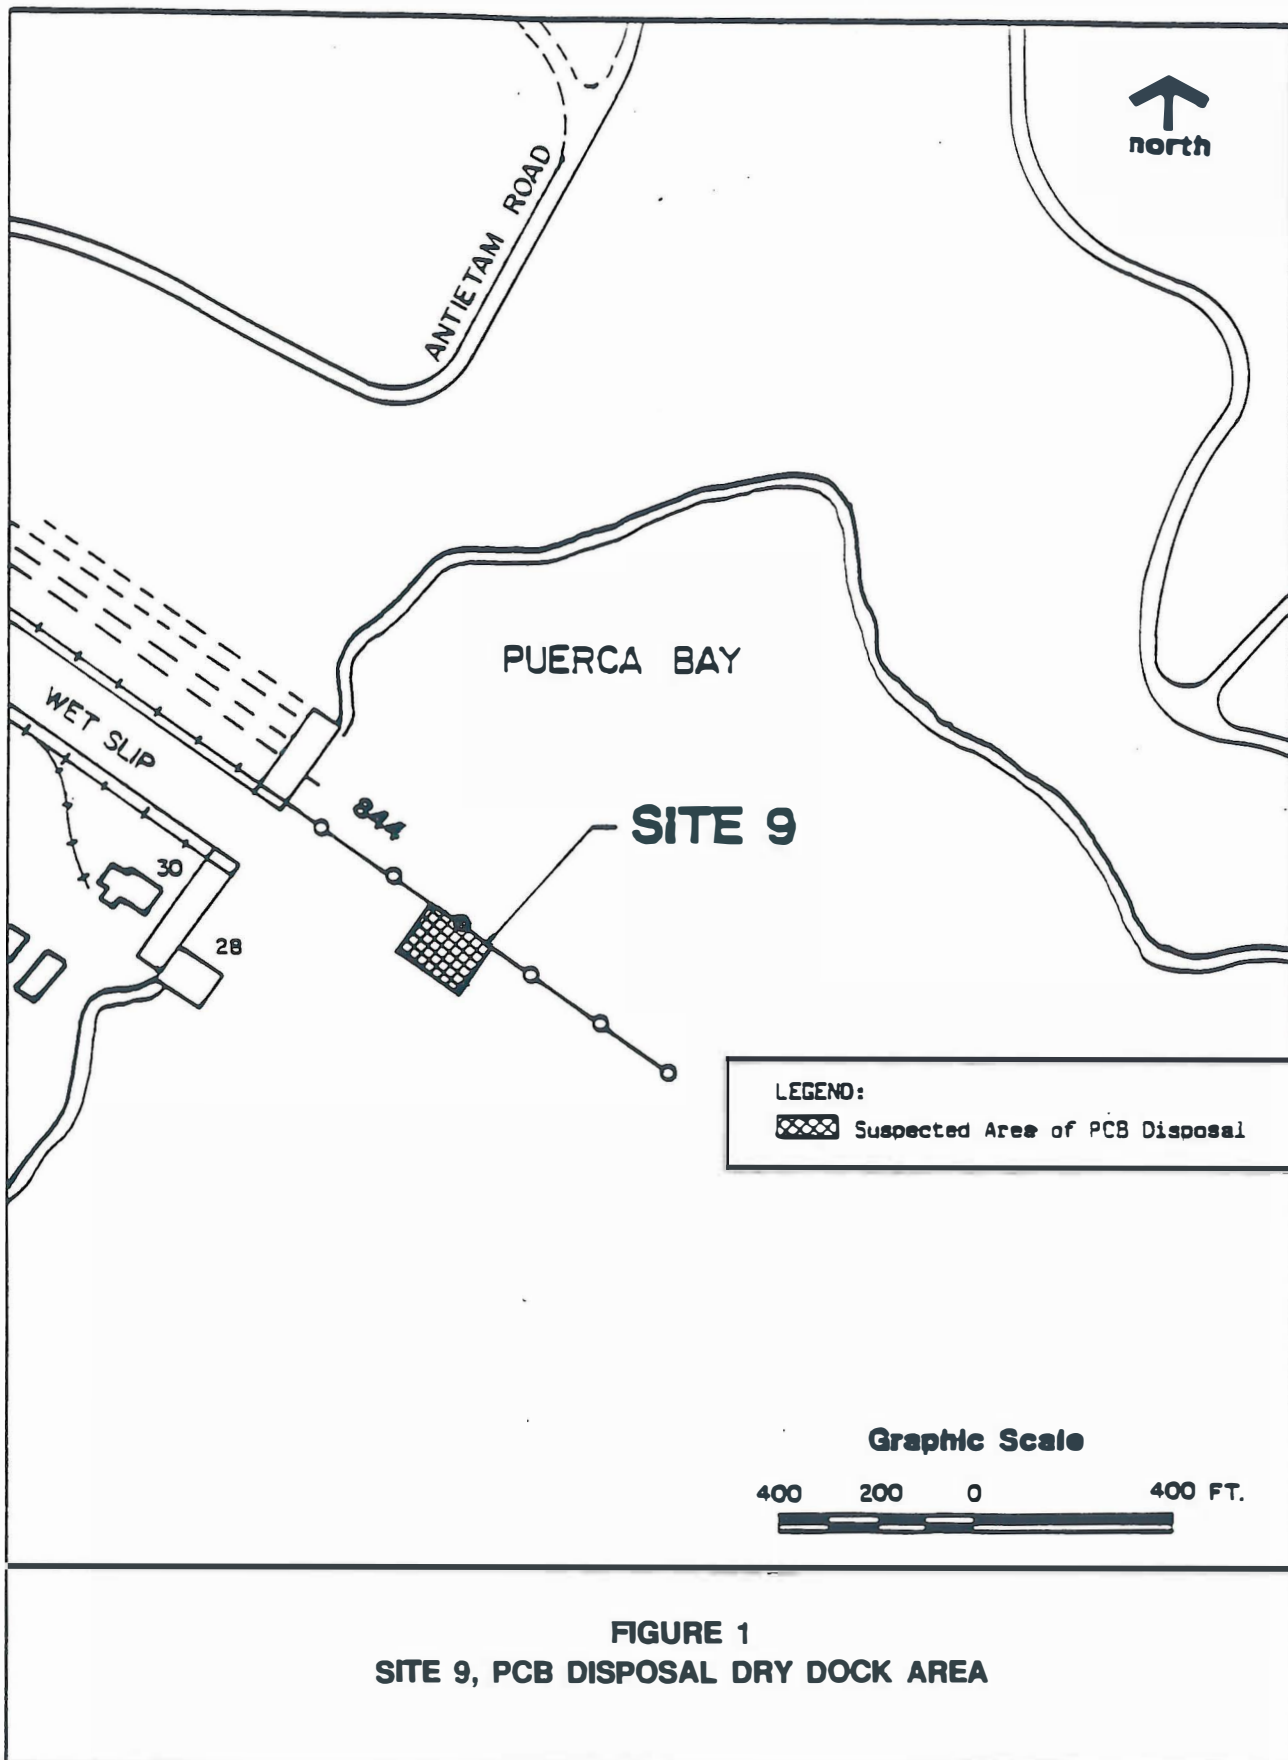
In approximately 1968, 25 5-gallon cans containing Askarel (a PCB dielectric fluid) were reportedly disposed of by dropping them into Puerca Bay off the south side of the wharf at the dry dock (Figure 1). Some of the cans, which had been stored in Public Works Building 31, were in a rusty condition at the time of the disposal.

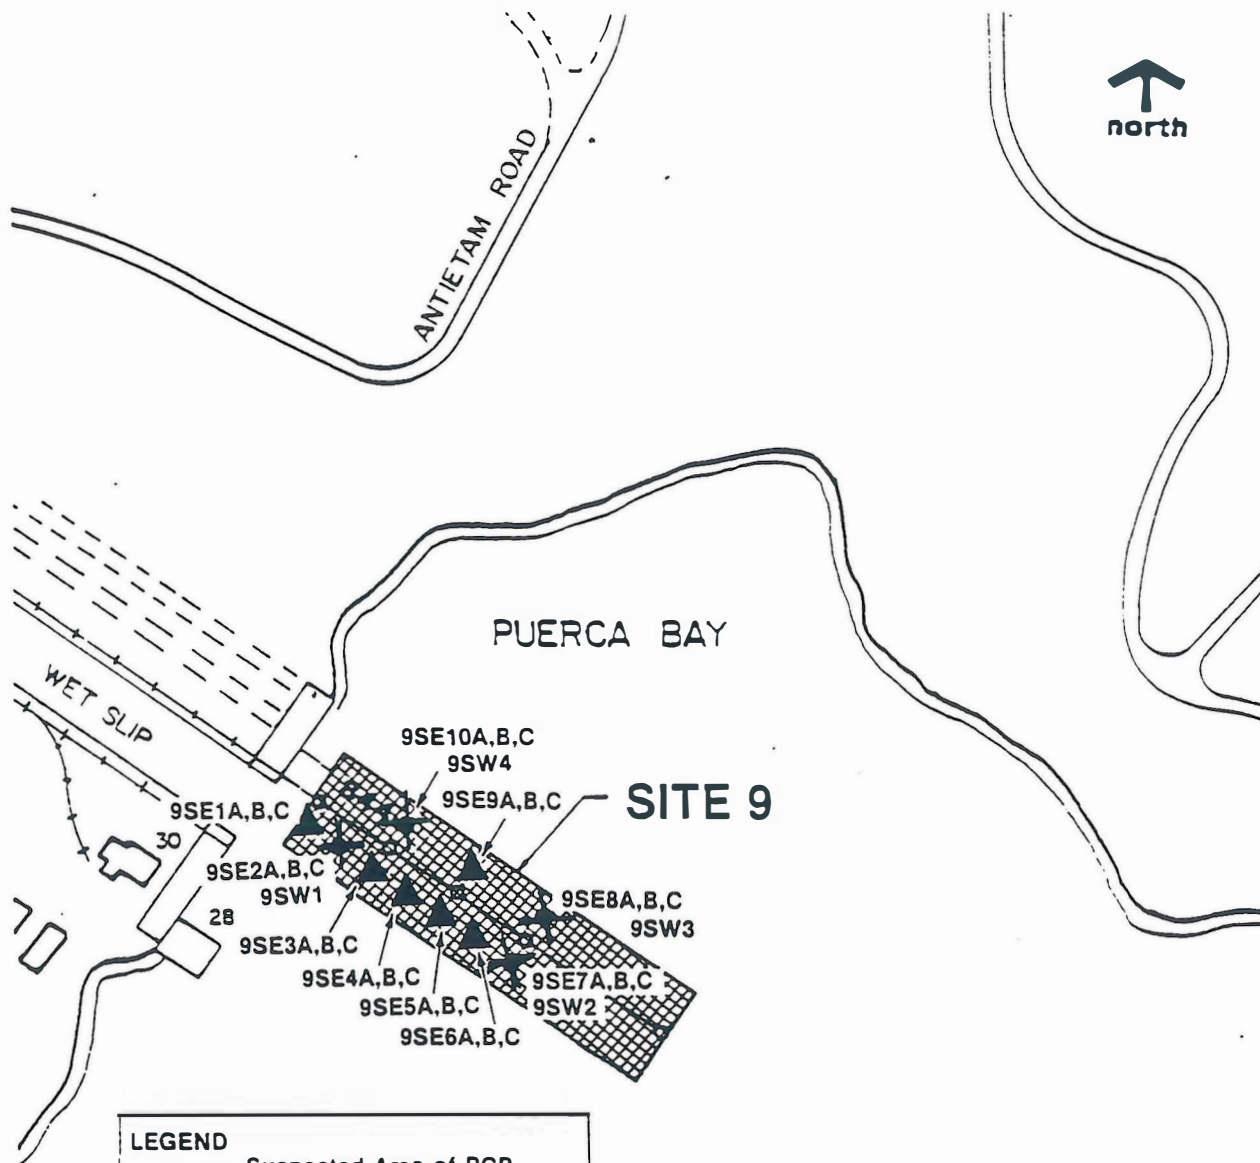
FIGURE 2
SAMPLING LOCATIONS AT SITE 9,
PCB DISPOSAL, DRY DOCK AREA

Because none of the 5-gallon metal cans allegedly disposed were located, the investigation proceeded using the randomized sampling program. Two sediment samples were also collected on both sides of the pier's third stanchion where the disposal reportedly took place. Surface water and sediment samples were collected at the site for PCB analysis. Figure 2 shows the sampling locations. No PCBs were detected in any of the surface water or sediment samples that were analyzed.
